**ENVIRONMENTAL AND SOCIAL MANAGEMENT PLAN (ESMP)
FOR ASBESTOS WASTE**

**Prepared under
REHABILITATION WORKS IN THE RADONIQUI-DUKAGJINI IRRIGATION
SCHEME (Contract No. KARP-W-21.1)**

NPT 'XËRXA' & 'GASHI ING' Shpk

June 2021

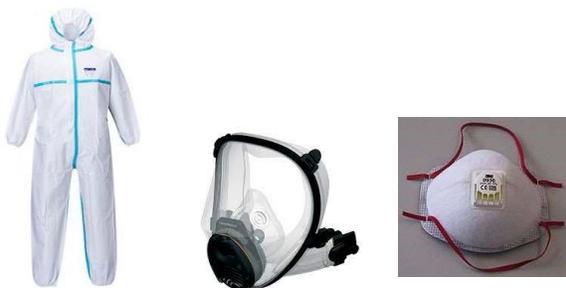
All work which will or may disturb ACM shall be accomplished utilizing, as a minimum, disposal suits with protective head cover, gloves, boots, eye protection and proper respiratory protection.

Figure 1: Example for personal protective equipment: clothing, full mask and FFP3 respiratory masks

Typically, different types of respiratory masks exist on the market. For the abatement of weakly bound asbestos materials full face respiratory masks are recommended. For handling of strongly bound asbestos containing materials such as asbestos cement the utilization of FFP3 “half” masks are

The Contractor shall provide hard hats and/or other protection as required for job conditions for safety of the workers. Disposal suits consisting of material impenetrable by asbestos fibers shall be provided to all workers. Workers shall be provided protective clothing from the time of first disturbance of ACM until final cleanup is completed.

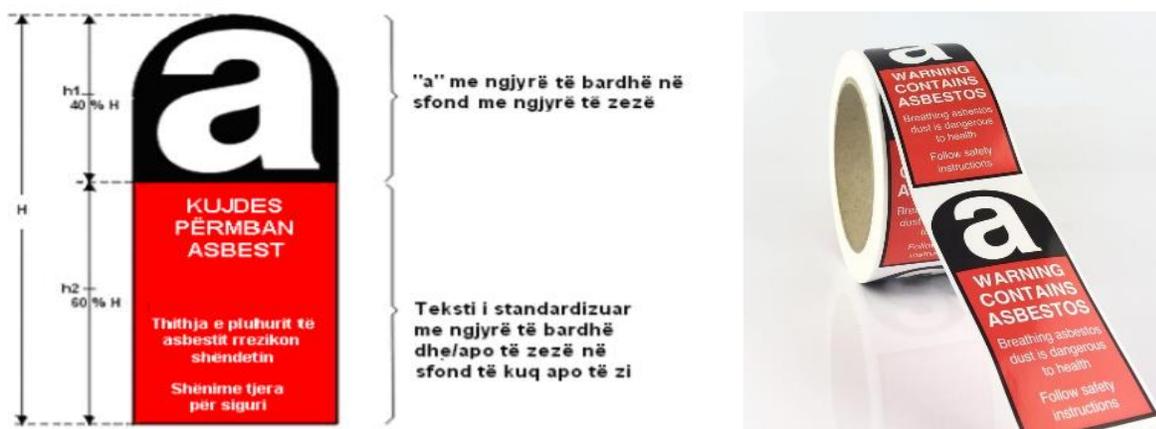
Where the label is printed directly onto a product, a single-color contrasting with the background color is be used.

The label shall be clearly and indelibly printed so that the words in the lower half of the label can be easily read, and those words shall be printed in black or white.

Figure 2 – Example of label for asbestos

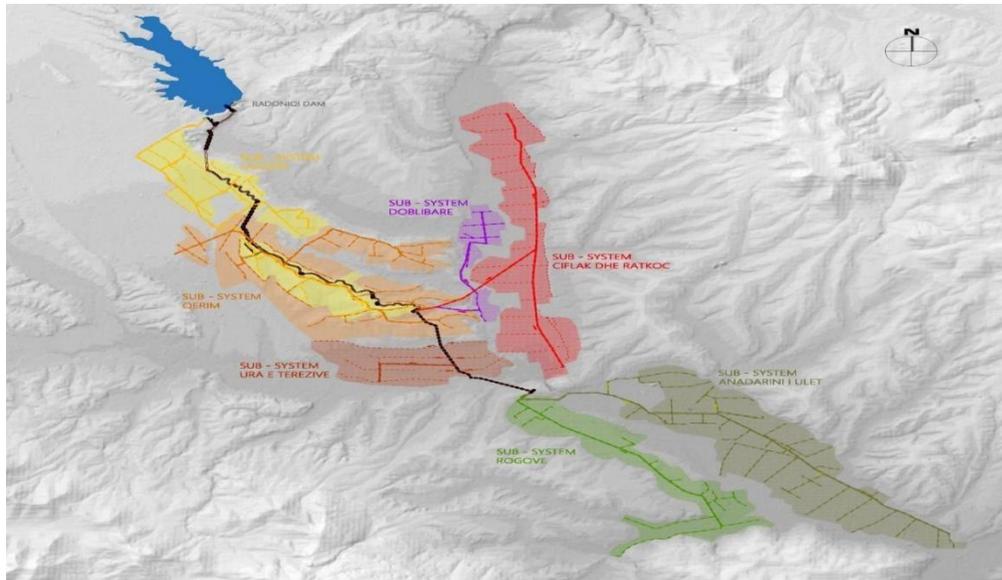
Figure 2. Map of the Radoniqi irrigation scheme

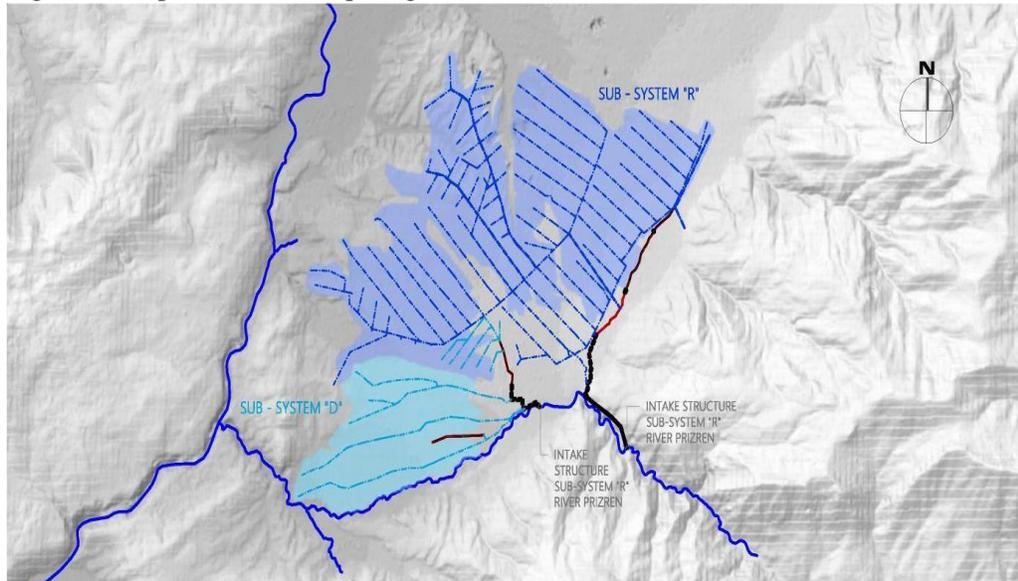
Figure 3. Map of the Dukagjini irrigation scheme
